COMMISSION OF INQUIRY INTO THE AIR ONTARIO CRASH AT DRYDEN, ONTARIO

Final Report

Volume II

Part Five

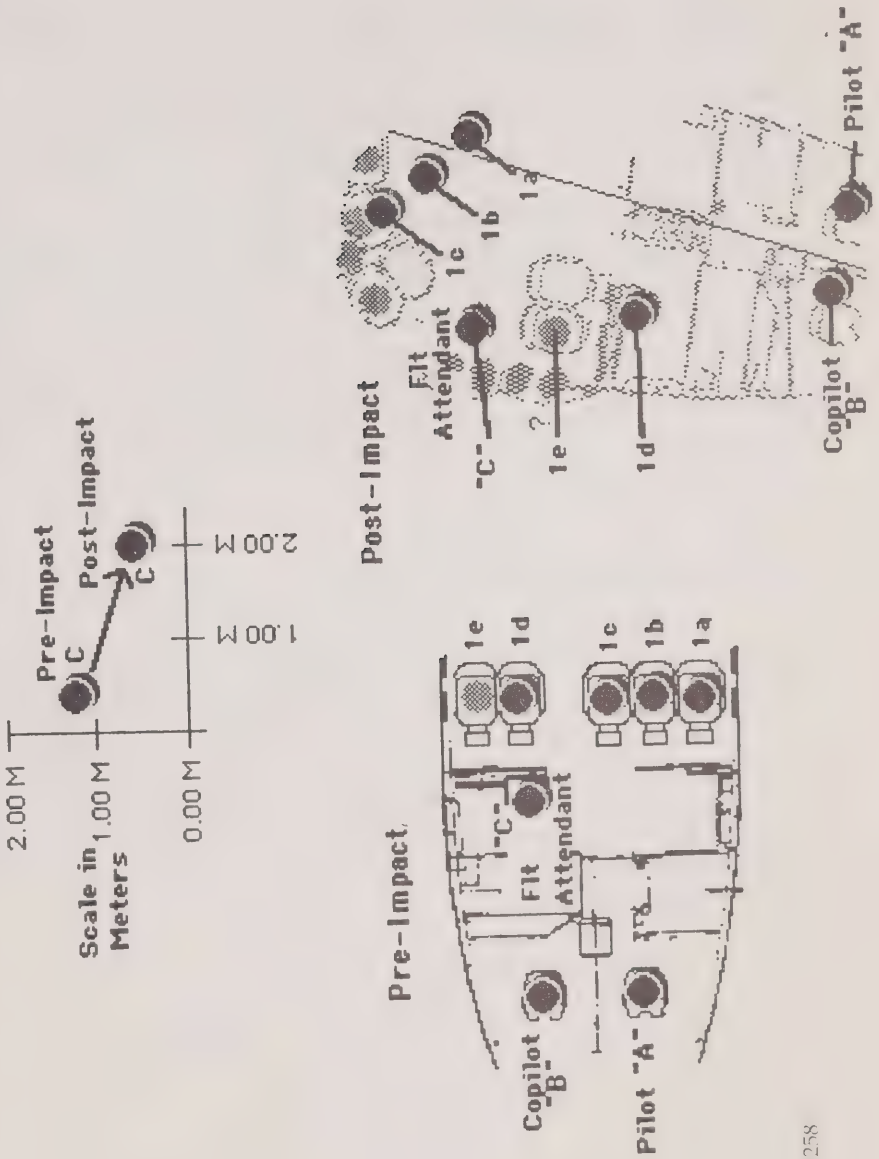
Figure 22-1 Pre- and Post-Accident Locations of Individuals Seated in Forward Positions on Flight 1363

Although other factors may have intervened to cause her head injury during the breakup sequence, it is beyond dispute that, had she been secured by a shoulder harness, her upper body would have been markedly better restrained and protected from injury caused by forward motion on impact. This, after all, is the function of a shoulder harness.

Whether Mrs Say would have been able to aid passengers or eventually to make her way out of the wreckage had she not sustained the head injury cannot be stated. What can be said is that her chances for survival may have been enhanced if she had had the protection of a shoulder harness.
